SUBJECT: Steering Committee/ARGO Meeting, 1 October 1969

HURRICANE "CAMILLE"

An Appreciation of the Damage As Interpreted
from Aerial Photography

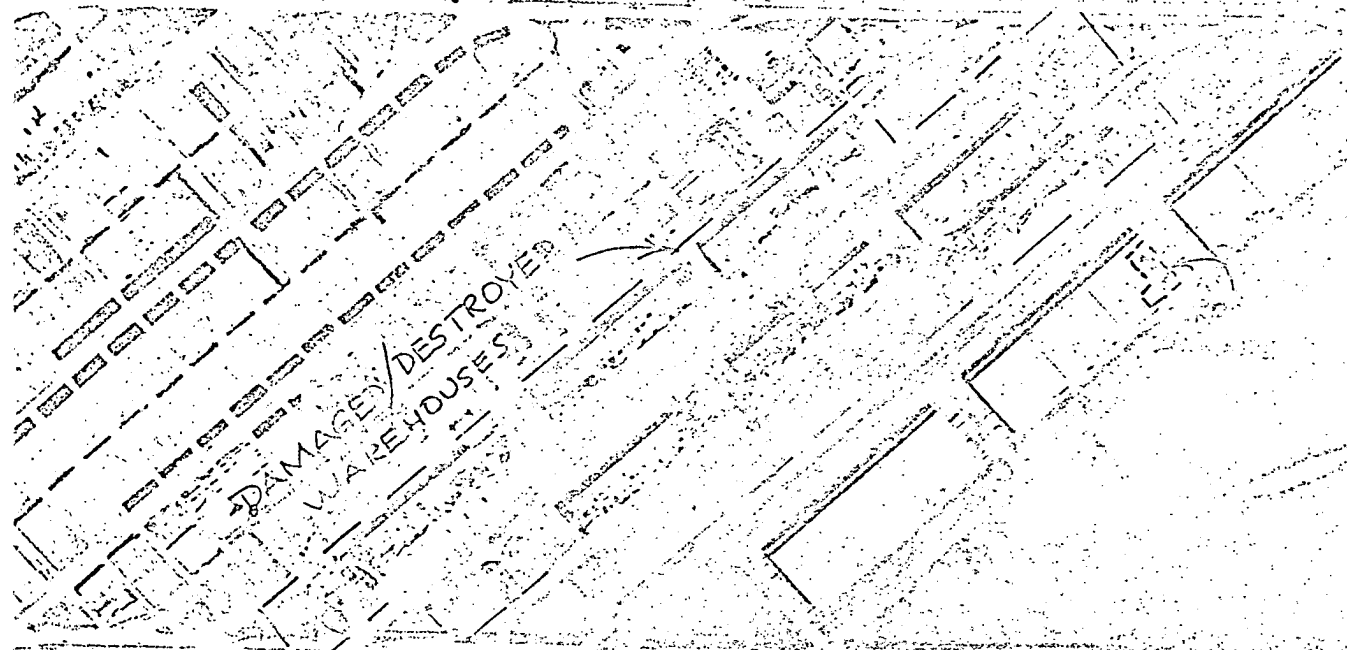
U.S. NAVAL RESERVATION
GULFPORT, MISS.

- 6 large warehouse buildings (550' x 110')
almost totally damaged
- 4 warehouses (230' x 90') destroyed
- 17 warehouses (185' x 40') severely damaged
